第 126 回定例研究会 資料 II

**疲労限度線図以下の応力による疲労破壊現象に  
及ぼす切欠き形状と侵入水素の影響**

**九州大学**

**近藤 良之**

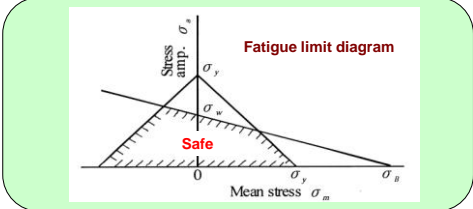
**Reduction of fatigue strength by under-stress**

It is often assumed that fatigue fracture would not occur when all stress amplitudes are within fatigue limit diagram.

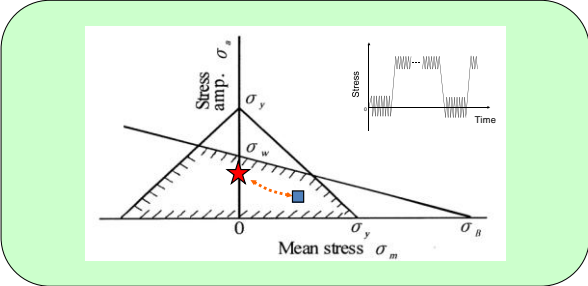
**In some special loading history, fatigue fracture occurs in the case of notched specimen, even when all stresses are within fatigue limit diagram.**

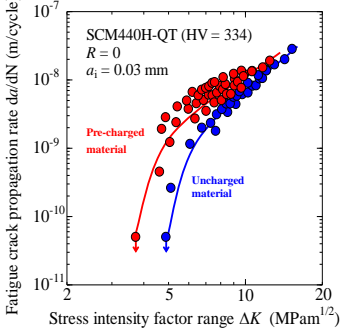
**Absorbed hydrogen reduces fatigue strength**

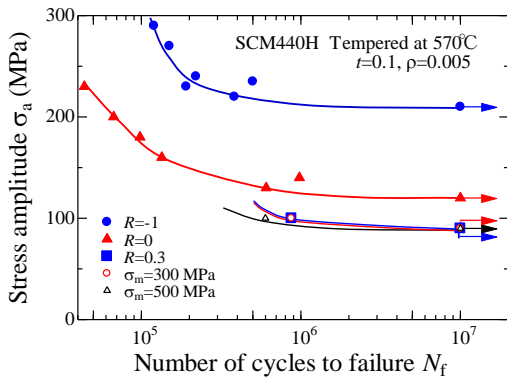
**Fatigue fracture below fatigue limit**

Sharp notch: ( $\rho = 5\mu\text{m}$ ,  $t = 100\mu\text{m}$ )

- (1) Fatigue fracture below fatigue limit occurred even in 10μm deep notch.
- (2) In two-step load, a non-propagating crack is formed by the first step stress ( $R=-1$ ). Thus-formed crack functioned as a pre-crack for the second step stress with high mean stress. It propagated under stresses well below fatigue limit.
- (3) Fatigue fracture below fatigue limit was triggered when the  $\Delta K$  of non-propagating crack for the second step stress exceeded the  $\Delta K_{th}$  of constant amplitude.
- (4) Absorbed hydrogen caused additional reduction of fatigue limit in two-step loading.

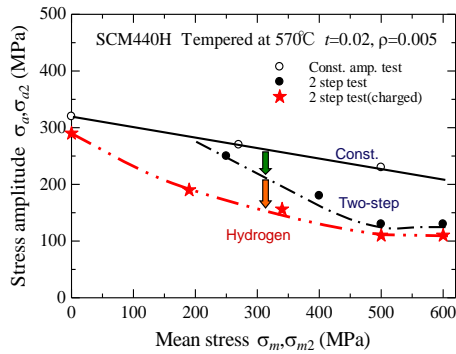
**Effect of absorbed hydrogen on fatigue limit**

• Another reduction was caused by absorbed hydrogen.

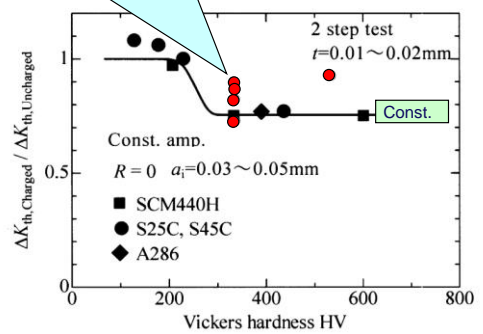
**Comparison between const. amp. and two-step loading**

Reduction caused by hydrogen is the same
